METALS HANDBOOK

VOL. 9
FRACTOGRAPHY AND ATLAS OF FRACTOGRAPHY

8th EDITION

Fractography and Atlas of Fractographs

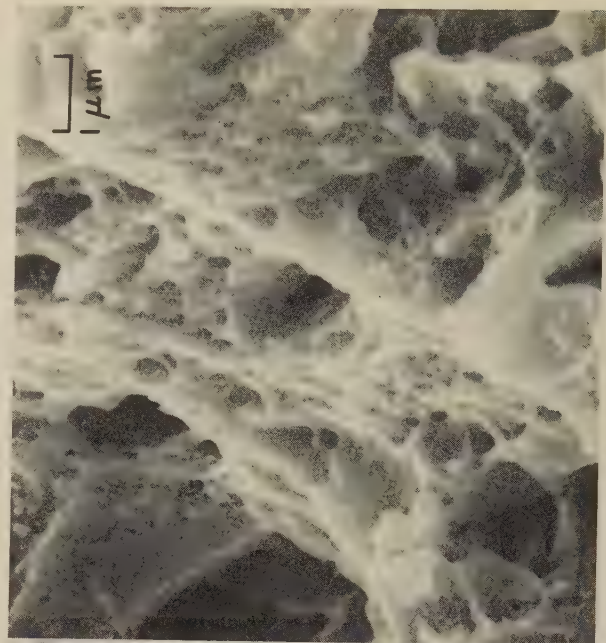
3821 Higher-magnification view of the area in the rectangle in 3820 (left). Very fine dimples and large facets are both present. A few features resemble cleavage facets, but the grain-boundary parting expected in hydrogen-embrittled fractures is absent.

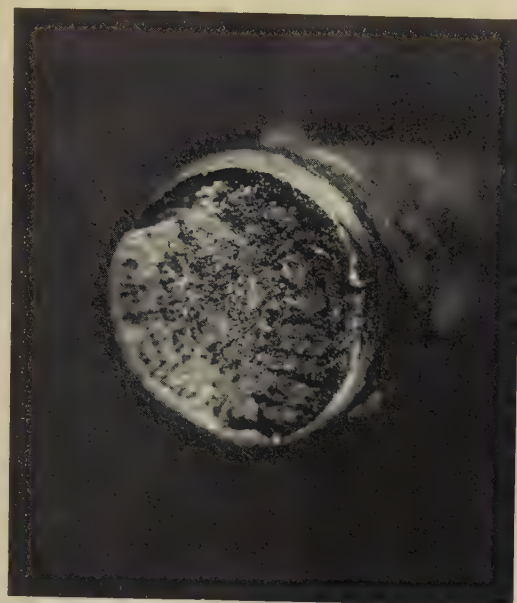
Light fractograph
3824 6× Fracture caused by stress-corrosion cracking in a threaded specimen of H11 tool steel (same heat treatment and tensile strength as in 3816) at a sustained loading of 75% tensile strength in a 3.5% NaCl environment at room temperature. Appreciable corrosion is evident. See also 3825 to 3827.

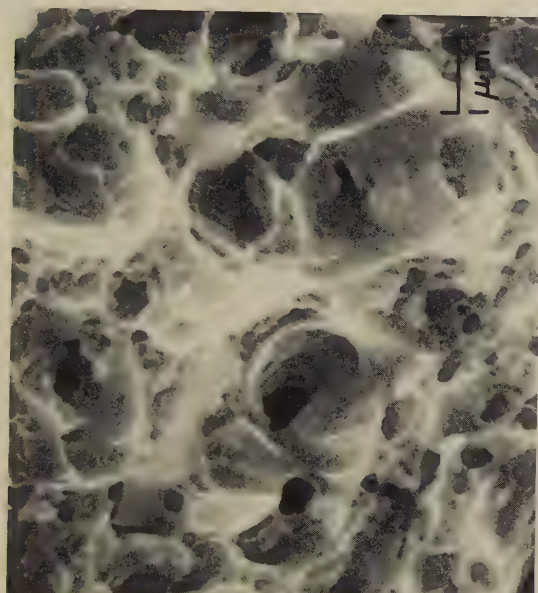
SEM fractograph
3823 10,000× Higher-magnification view of a region of which most is contained within the rectangle in fractograph 3822 (left). This region, like the one shown in 3821, exhibits a considerable range in dimple size and no trace of grain-boundary parting.

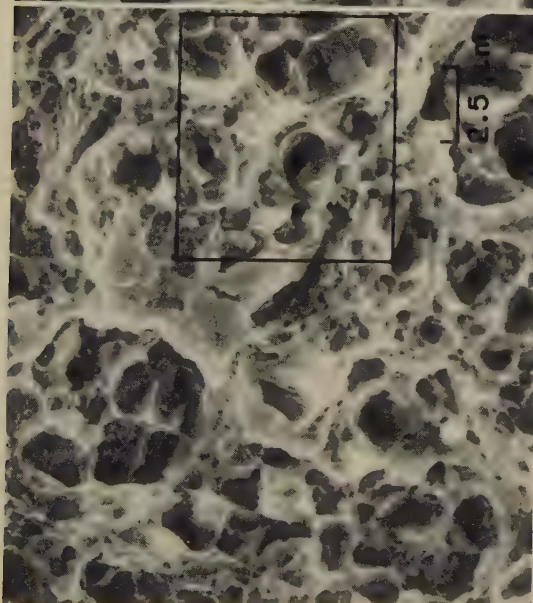
SEM fractograph
3822 4000× Another view of the fracture surface in hydrogen-embrittled H11 tool steel shown in 3819 (facing page). The surface consists almost entirely of dimpled rupture. A few facets are present and suggest possible local cleavage. See 3823.

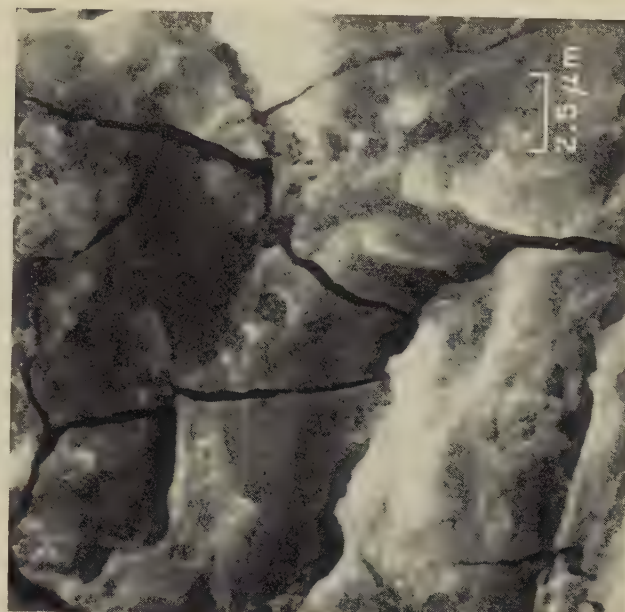
SEM fractograph
3827 4000× High-magnification view of a region of the fracture in 3824 not shown in 3825, displaying grain-boundary facets and some corrosion. Some of the deep secondary cracks may be transgranular.

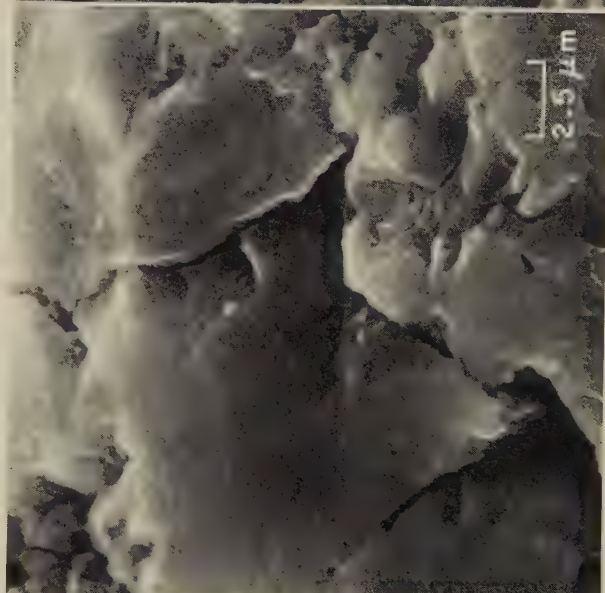
SEM fractograph
3826 4000× Higher-magnification view of the area in the rectangle in 3825, showing secondary cracking, which appears to follow some grain boundaries. The large, smooth facets resemble transgranular cleavage more than they resemble grain-boundary rupture.

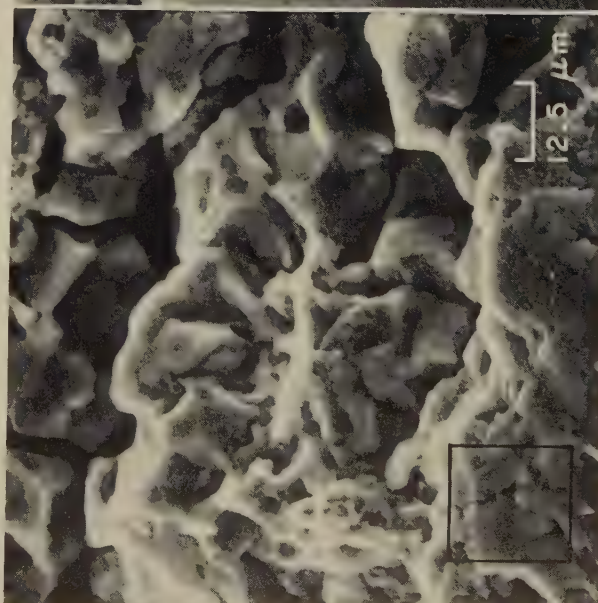
SEM fractograph
3825 800× SEM view of the fracture surface in 3824, showing fracture by grain-boundary cracking under NaCl attack. Some facets show no trace of corrosion. Deep secondary cracks are present. A few facets suggest quasicleavage. See 3826.

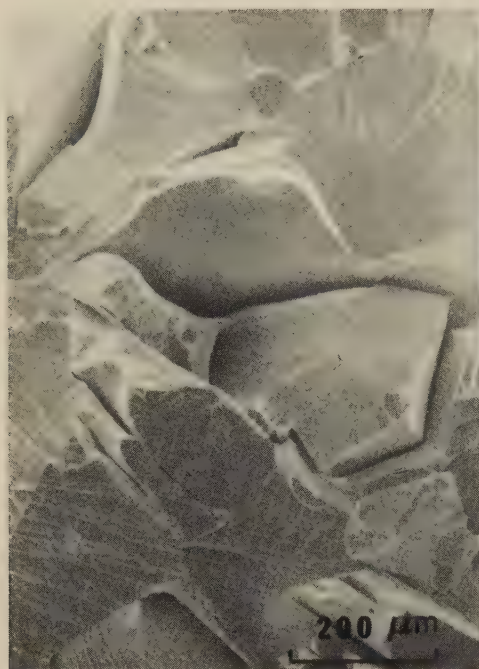
SEM fractograph 100×
3828 Fracture surface in an iron-base alloy containing 7 at. % (6.4 wt %) Cr and 1 at. % (3.2 wt %) Ta, pulled in tension at room temperature after solution treatment for 1 hr at 1320 C (2408 F) and water quenching, then aging at 700 C (1292 F) for 40 min and air cooling. Fracture was by transgranular cleavage believed to have originated at a grain-boundary network of Laves-phase Fe_2Ta precipitate. See 3829-31.

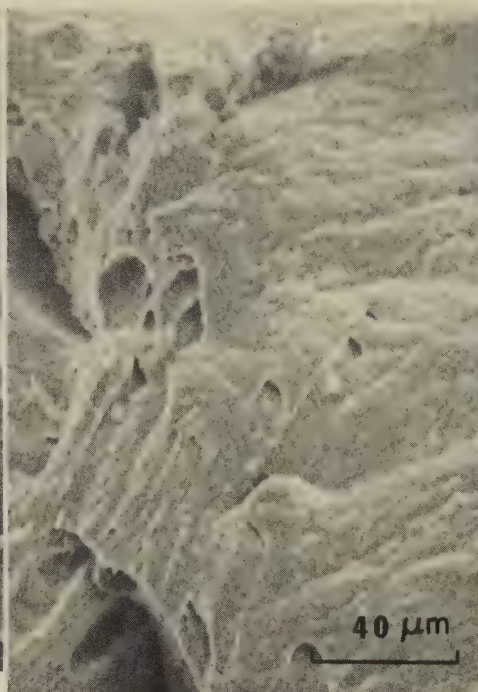
SEM fractograph 500×
3829 Fracture surface in a specimen of the same Fe-Cr-Ta alloy, and with the same heat treatment, as in 3828, but tensile tested at 200 C (392 F). In addition to cleavage, this fracture shows features of quasicleavage, but the higher test temperature provided greater ductility and a number of elongated dimples made their appearance. See also 3830 and 3831.

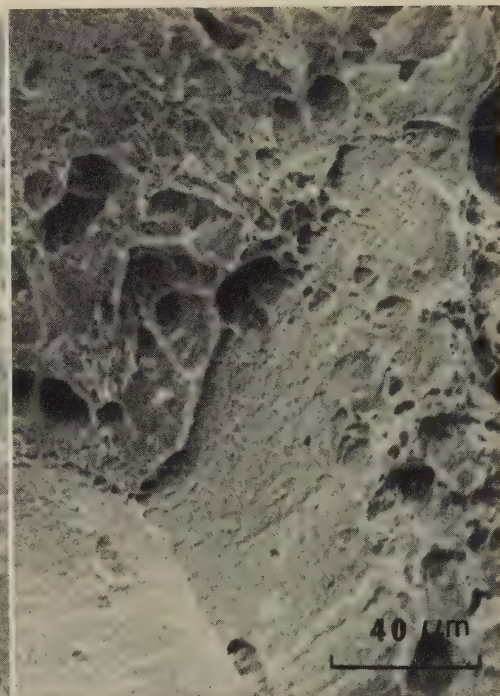
SEM fractograph 500×
3830 Same Fe-Cr-Ta alloy, and with the same heat treatment, as in 3828 and 3829, but fractured by tension overload at 400 C (752 F). Its appearance suggests rupture along two grain boundaries (at bottom center), as well as an increased quantity of dimples compared with the number present in 3829. The dimples here are also much more equiaxed than those in 3829. See 3831.

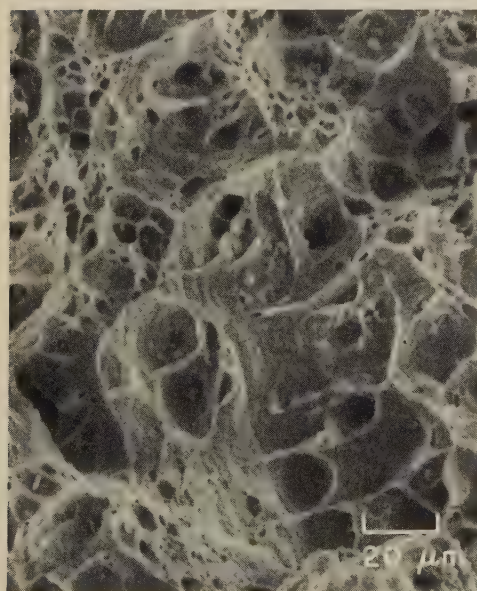
SEM fractograph 500×
3831 Fracture surface in a specimen of the same Fe-Cr-Ta alloy, and with the same heat treatment, as in 3828, 3829 and 3830, but which was broken in tension at 600 C (1112 F). At this test temperature, the ductility was sufficient to eliminate completely both cleavage and intergranular mechanisms of failure, and fracture occurred entirely by microvoid coalescence.

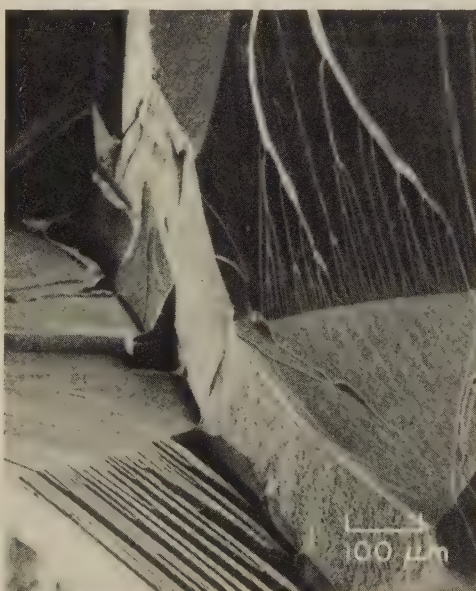
SEM fractograph 100×
3832 A room-temperature tensile fracture by cleavage of an Fe-2 at. % (6.2 wt %) Ta alloy solution treated 1 hr at 1400 C (2552 F), water quenched, aged 1 hr at 700 C (1292 F), air cooled. Laves-phase Fe_2Ta precipitate, uniformly distributed in the matrix and believed present at grain boundaries, caused brittleness (<1% tensile elongation). See also 3833.

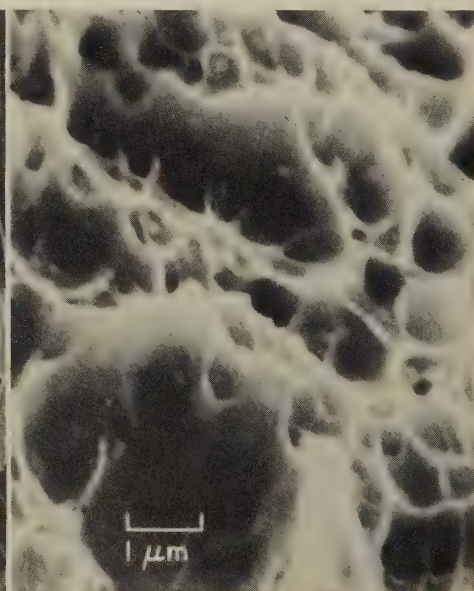
SEM fractograph 10,000×
3833 A room-temperature tensile fracture in a specimen of the same alloy as in 3832, given the same heat treatment plus a spheroidizing treatment of 10 min at 1100 C (2012 F) and air cooling. Spheroidization of precipitates at grain boundaries and within grains, plus a finer grain size than in 3832, resulted in dimpled fracture and 22% tensile elongation.

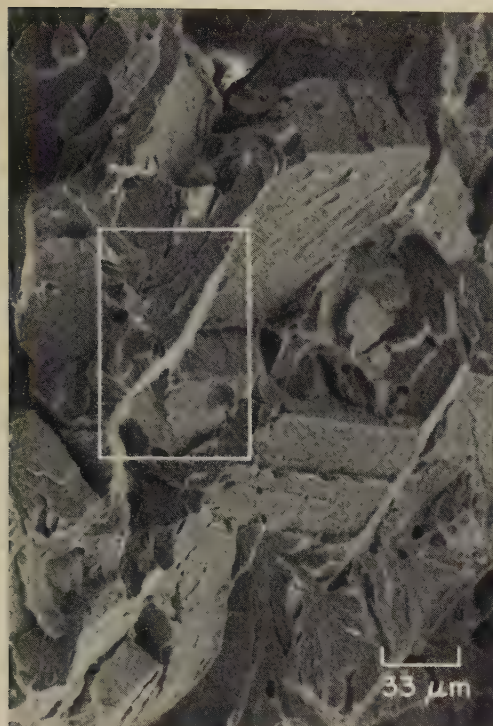
SEM fractograph 300×
3834 Charpy impact fracture in 0.18% C, 3.85% Mo steel after heat treatment in an inert atmosphere at 1200 C (2192 F) for 1 hr, followed by an ice-10% brine quench. Many quasicleavage facets are visible. See fractograph 3835 (an enlargement of the area in the rectangle).

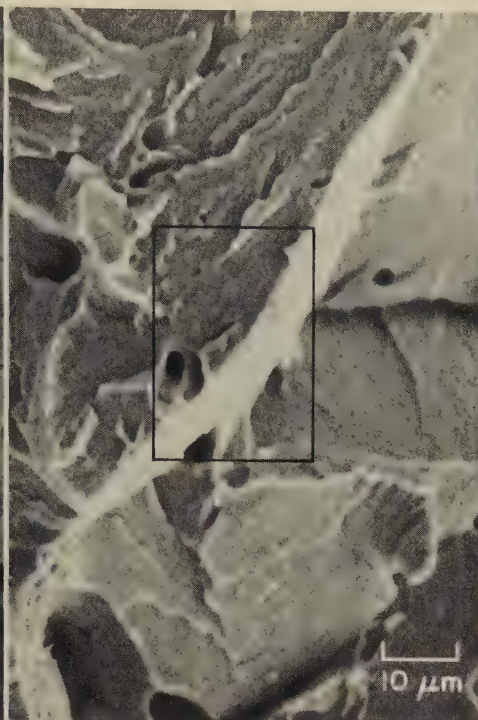
SEM fractograph 1000×
3835 Area outlined by the rectangle in 3834, shown at higher magnification, which makes details of the quasicleavage more clearly evident. A few elongated dimples are present. Area in the rectangle here is shown at higher magnification in fractograph 3836, at right.

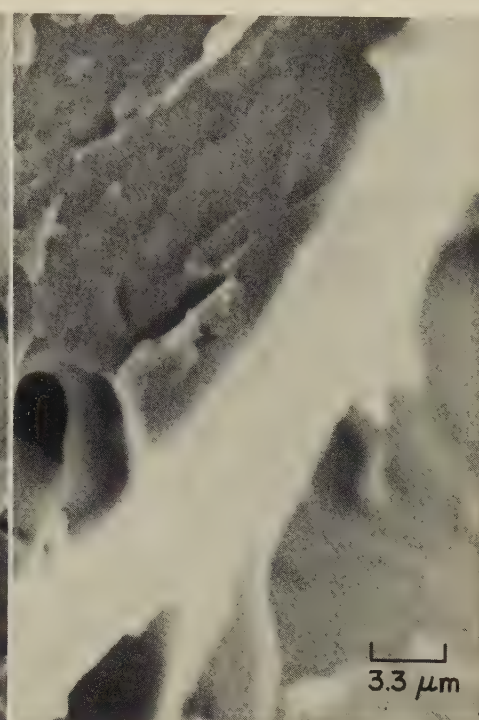
SEM fractograph 3000×
3836 Area outlined by the rectangle in 3835, shown at higher magnification. The bright tilted facet may be a grain boundary or a tear ridge. An inclusion is faintly visible in the dimple about midway along the left edge.

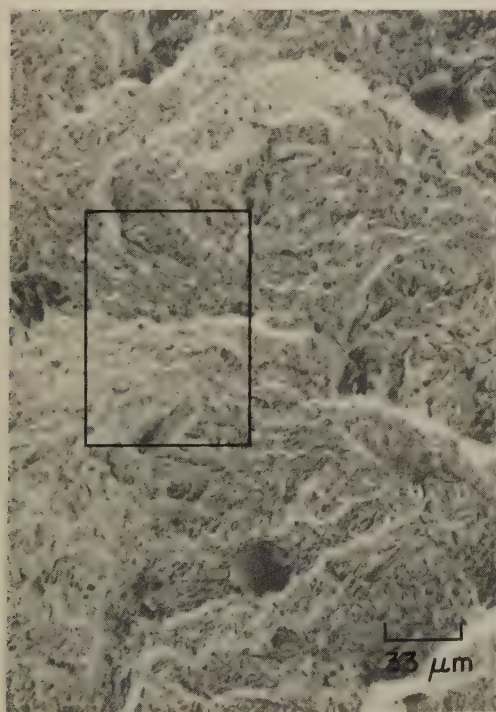
SEM fractograph 300×
3837 Charpy impact fracture in 0.41% C, 4.2% Mo steel after the same heat treatment as that for the specimen in 3834. This fracture occurred by dimpled rupture, although the impact energy was only 1/3 that of 3834. See 3838 and 3839.

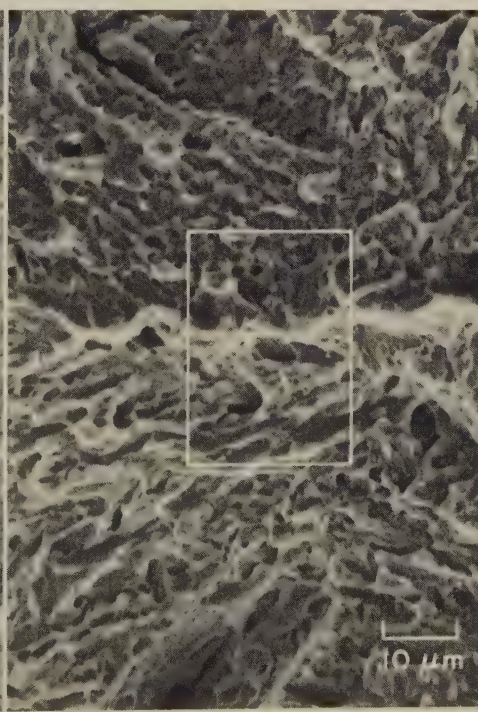
SEM fractograph 1000×
3838 This view at higher magnification of the area outlined by the rectangle in 3837 reveals that many of the dimples are highly elongated, exhibiting locally some features suggestive of cleavage. Area in rectangle here is shown enlarged in 3839.

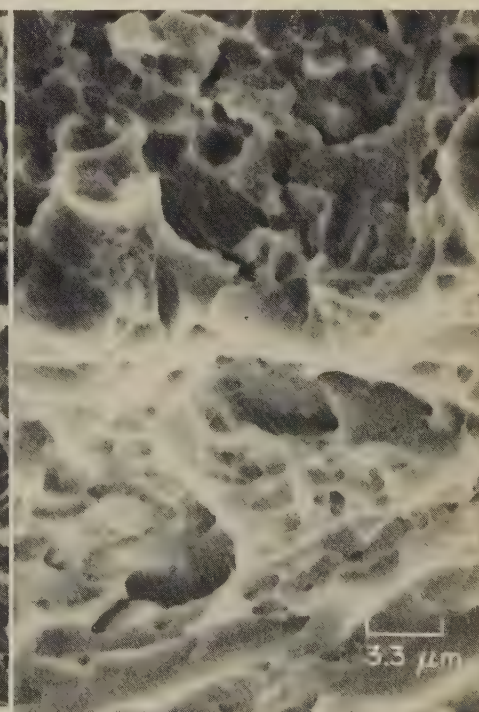
SEM fractograph 3000×
3839 Area outlined by the rectangle in fractograph 3838, shown at triple the magnification. At this enlargement, many extremely fine dimples are visible, formed along the margins of larger voids.

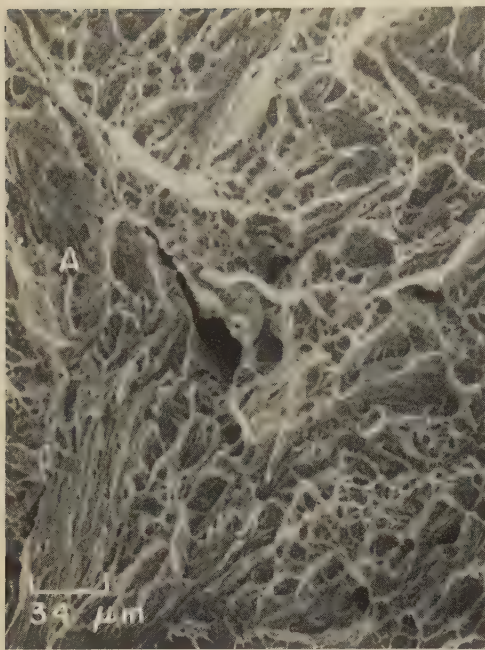
SEM fractograph 290×
3840 This specimen was austenitized at 1204 C (2200 F). Yield strength was 1413 MPa (205 ksi). There appear to be large facets of quasicleavage, such as at A; elsewhere, the surface contains rather large dimples. Note the large void near the center.

The fractographs on this page show the effects of various austenitizing treatments on characteristics of fractures in an experimental secondary-hardening steel containing 0.3% C, 0.6% Mn and 5.0% Mo. All specimens were austenitized for 1 hr at the temperatures indicated, quenched in ice-brine, and then refrigerated for 30 min in liquid nitrogen. Plane-strain fracture-toughness specimens were then tested at room temperature as part of a program to develop high levels of toughness in steels that also maintain ultrahigh tensile strength.

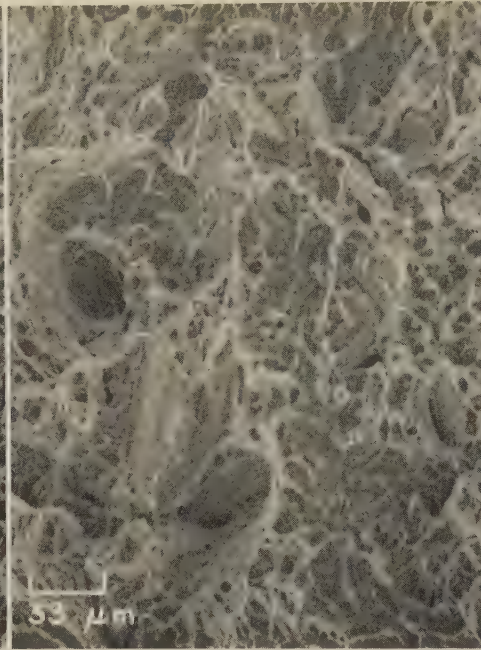
SEM fractograph 300×
3841 This specimen was austenitized at 1093 C (2000 F). This fracture, like that in 3840, displays quasicleavage facets; some of them are apparently rather deeply indented. There are also intervening regions showing clusters of equiaxed dimples.

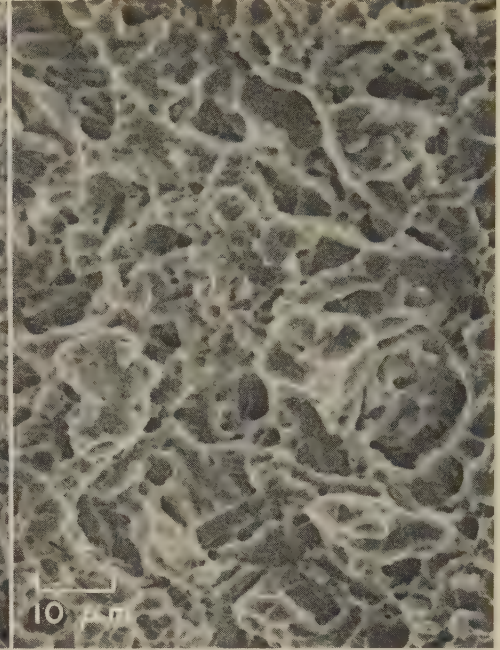
SEM fractograph 1000×
3842 This specimen, austenitized at 982 C (1800 F), shows none of the quasicleavage facets observed in 3840 and 3841. There appear to be many scattered dimples, but most of the surface consists of small facets, seemingly caused by cleavage.

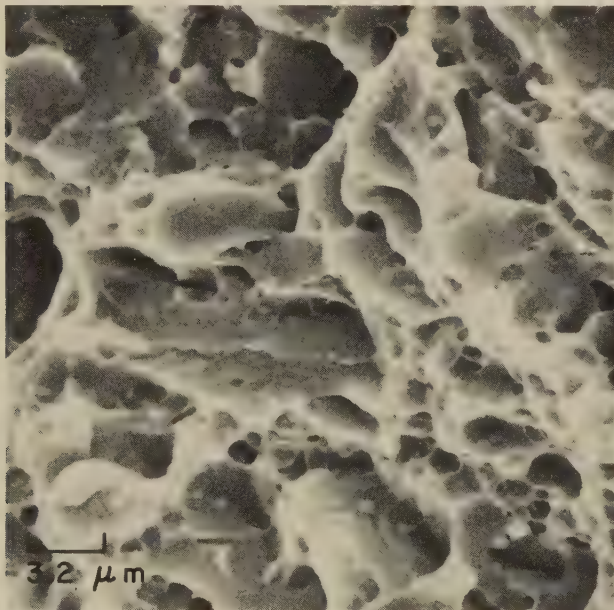
SEM fractograph 3150×
3843 This specimen was austenitized at 871 C (1600 F). Yield strength was 1324 MPa (192 ksi). The fracture surface exhibits a wide range of dimple sizes. The heat treatment resulted in a plane-strain fracture-toughness (K_{Ic}) value of 55 MPa·m^{1/2} (50 ksi·in.^{1/2}); this contrasted with a value of 121 MPa·m^{1/2} (110 ksi·in.^{1/2}) for the specimen in 3840—probably because of incomplete solution of carbide particles at the lower austenitizing temperature for the specimen shown here.

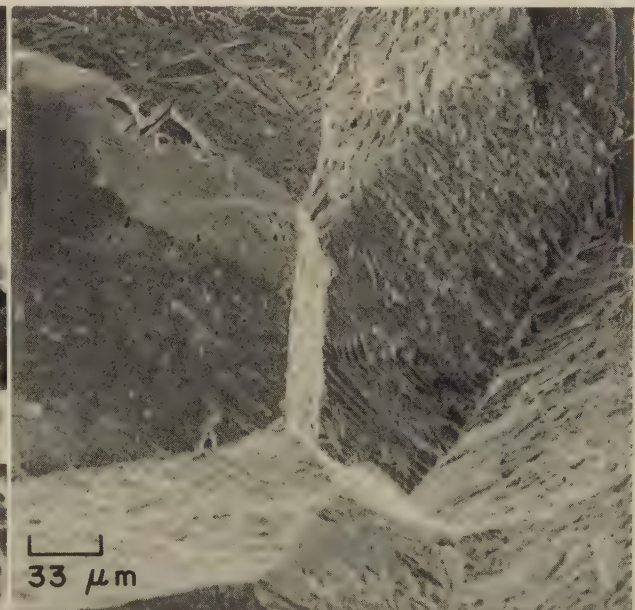
SEM fractograph 300×
3844 The heat treatment of this specimen was altered as follows: austenitize at 1204 C (2200 F) for 1 hr, quench to 871 C (1600 F) and hold for 30 min, ice-brine quench, then refrigerate in liquid nitrogen. Fracture appears to have occurred by a combination of transgranular and intergranular cleavage. The K_{Ic} value for this specimen was even lower than that for the specimen in 3843; the lower value is believed to be the result of a different distribution of carbide particles.

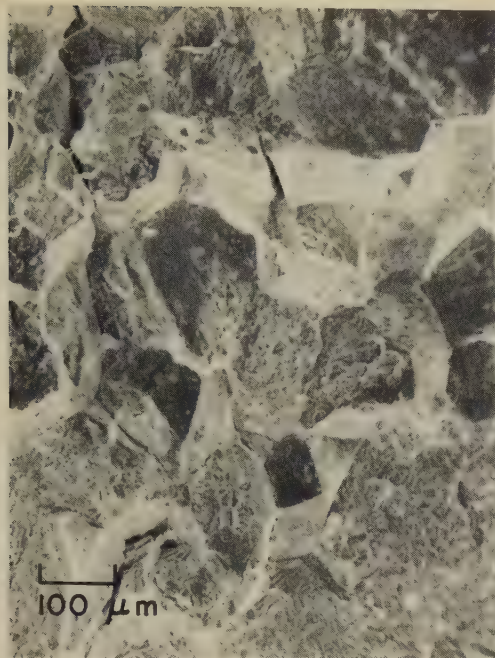
SEM fractograph 100×
3845 An area of the fracture surface in which the fracture appears to be intergranular, with secondary cracks between the grains. The lower portion of the area may contain dimples.

The fractographs above are of a fracture-toughness specimen of 0.4% C, 0.6% Mn, 5.0% Mo secondary-hardening steel that was tested as part of a program to develop fracture toughness in high-strength steel (the same program that yielded the fractographs on the facing page). This specimen was austenitized for 1 hr at 1204 C (2200 F),

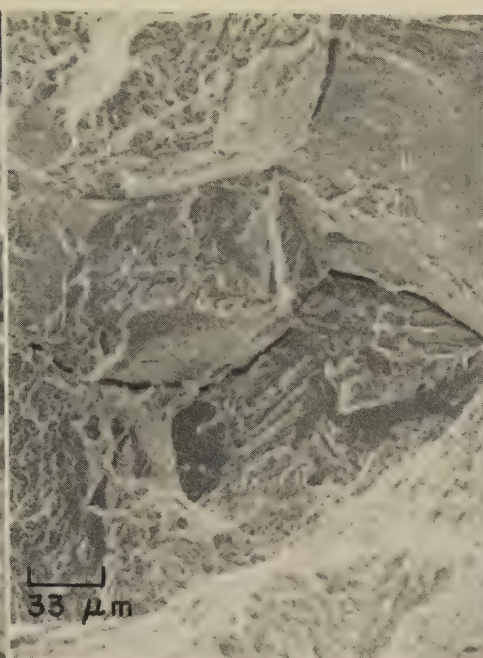
SEM fractograph 300×
3846 Another area of the fracture surface, shown at higher magnification. This area has many characteristics of an intergranular fracture. Grain surfaces exhibit fine dimples but no river patterns.

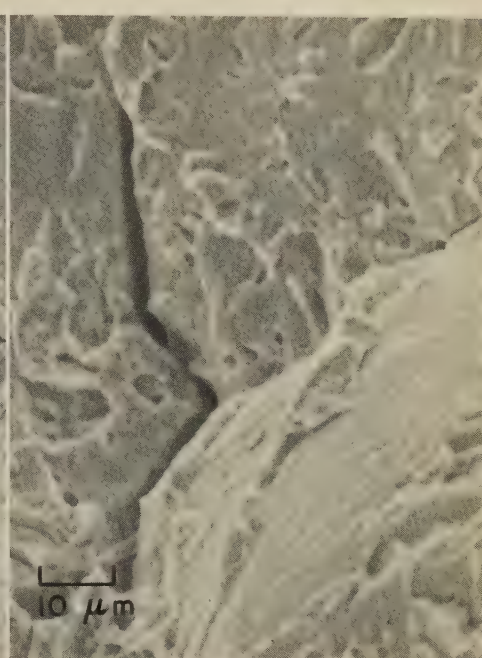
SEM fractograph 1000×
3847 A third area of the fracture surface, at still higher magnification. This area shows a secondary crack penetrating deeply into the grain boundary. Small cleavage steps are evident.

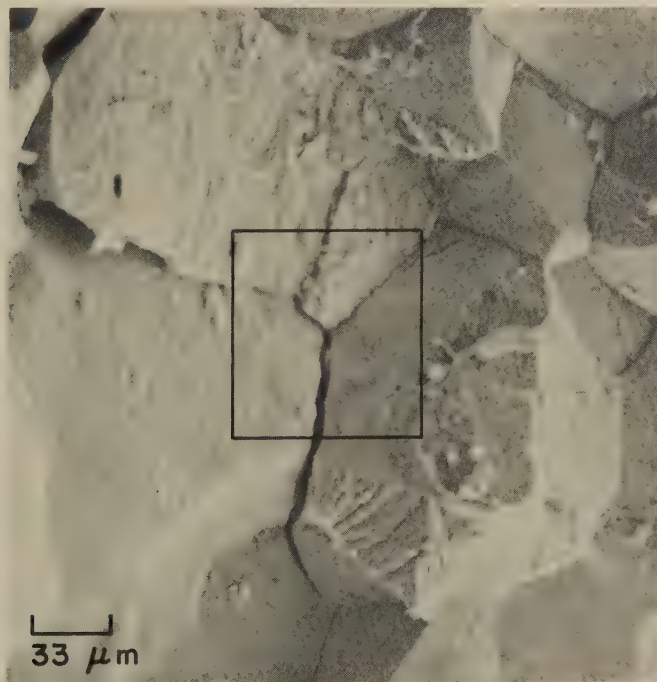
SEM fractograph 300×
3848 A V-notch Charpy impact fracture in a specimen of 0.42% C, 2.1% Mo, 5.2% Co alloy steel that was not as tough as had been expected. The fracture has been largely intergranular, although three facets appear to be transgranular cleavage facets. Note the secondary grain-boundary crack. Area in rectangle is shown enlarged in 3849.

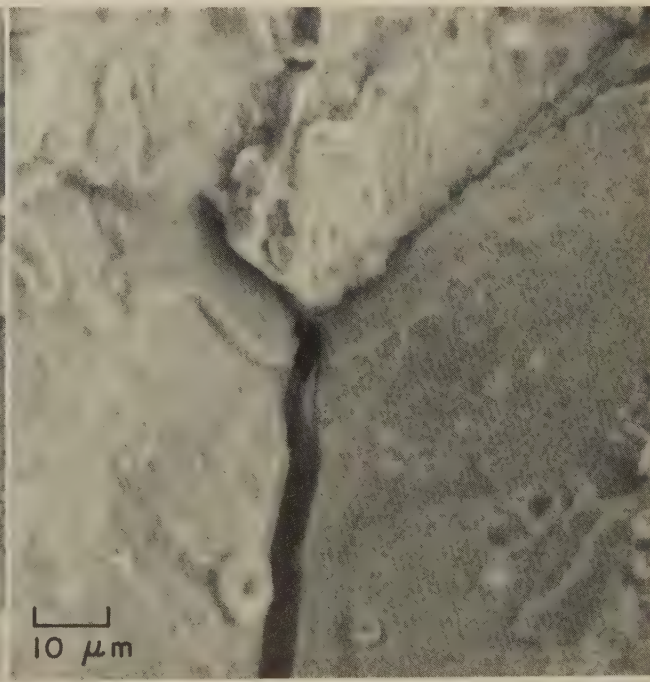
SEM fractograph 1000×
3849 Area outlined by the rectangle in 3848, shown at a higher magnification. The two facets in the lower portion are believed to be grain surfaces; facet in upper portion is believed to be a transgranular cleavage facet. The cause of the low toughness of this specimen was quench cracking. Small rings visible here may be artifacts.

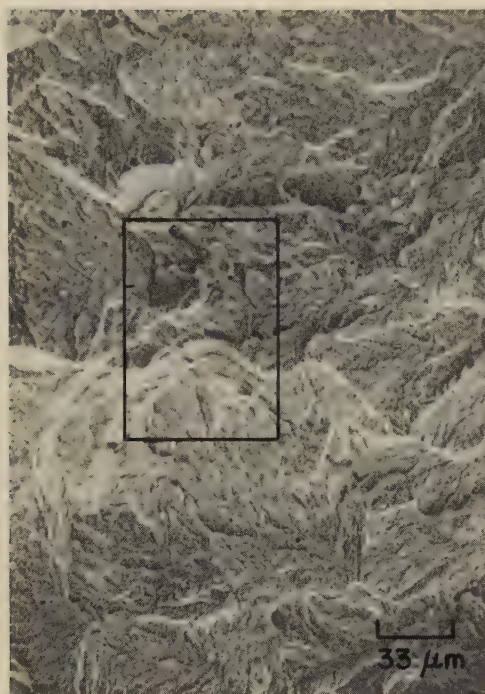
SEM fractograph 300×
3850 Charpy V-notch impact fracture in alloy steel (0.43% C, 3.85% Mo, 9.0% Co) that was heat treated in an inert atmosphere at 1200 C (2192 F) for 1 hr, then quenched in an agitated solution of ice and 10% brine. It appears that fracture was by a shear process. See 3851.

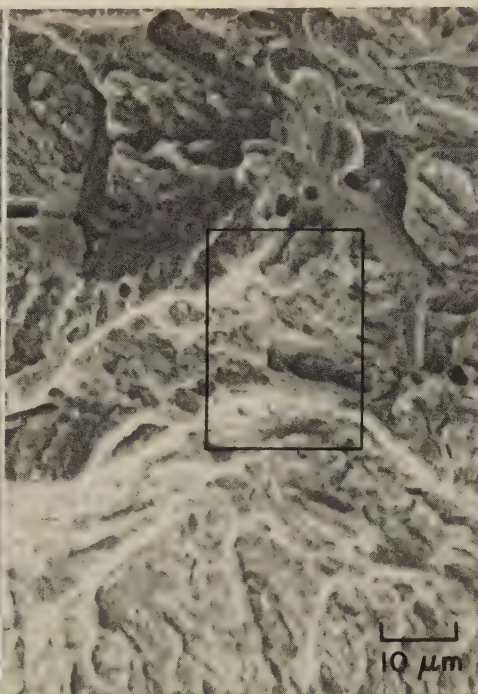
SEM fractograph 1000×
3851 Higher-magnification view of the area within the rectangle in 3850, showing more clearly the shear deformation and some isolated dimples. There appear to be small regions of local cleavage. See 3852 (right) for a higher-magnification view of the area in the rectangle here.

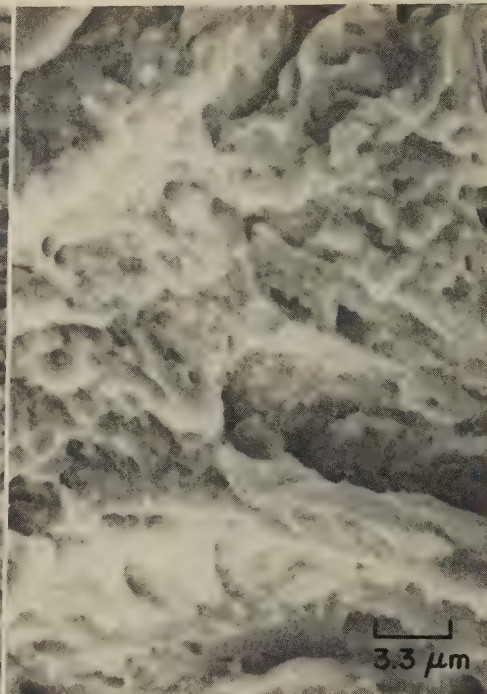
SEM fractograph 3000×
3852 Higher-magnification view of the area within the rectangle in 3851 (left), which reveals additional small dimples that are not readily apparent at the lower magnification. See also fractographs 3853 to 3855, for the effects of tempering on the fracture surface.

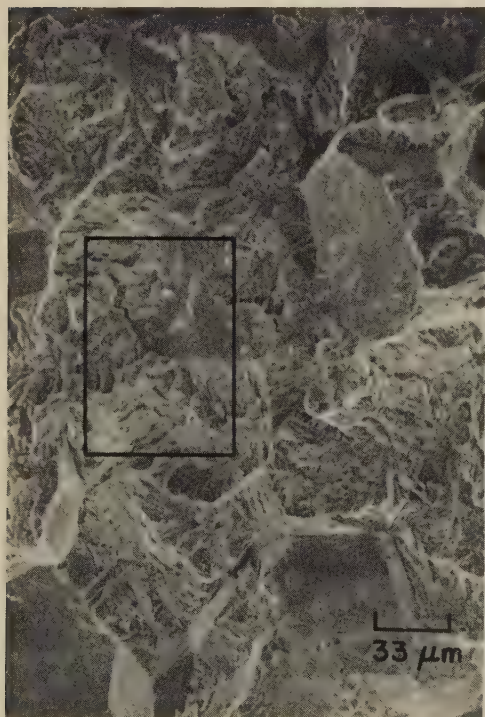
SEM fractograph 300×
3853 Charpy impact fracture in a specimen of the same alloy steel, and given the same austenitizing treatment, as in 3850, but then tempered for 1 hr at 600 C (1112 F), which maximized secondary hardening, and air cooled. See 3854.

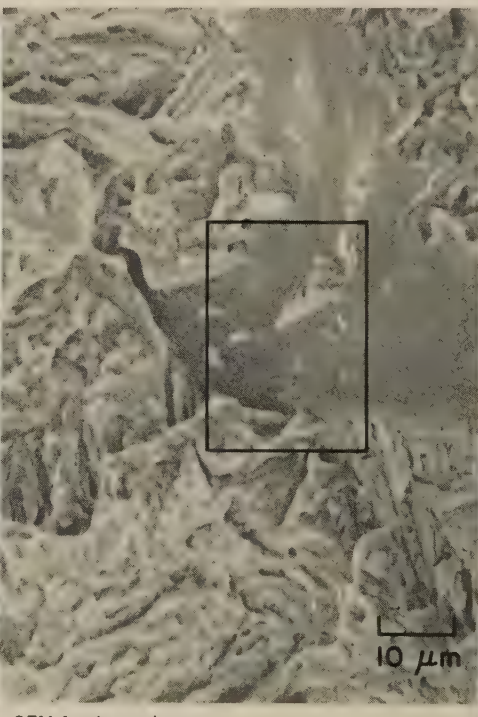
SEM fractograph 1000×
3854 An enlargement of the area in the rectangle in 3853 (left). This specimen, which had the same yield strength as that of the as-quenched specimen in 3850, fractured mainly by intergranular separation. See 3855 for a higher-magnification view of the area in the rectangle here.

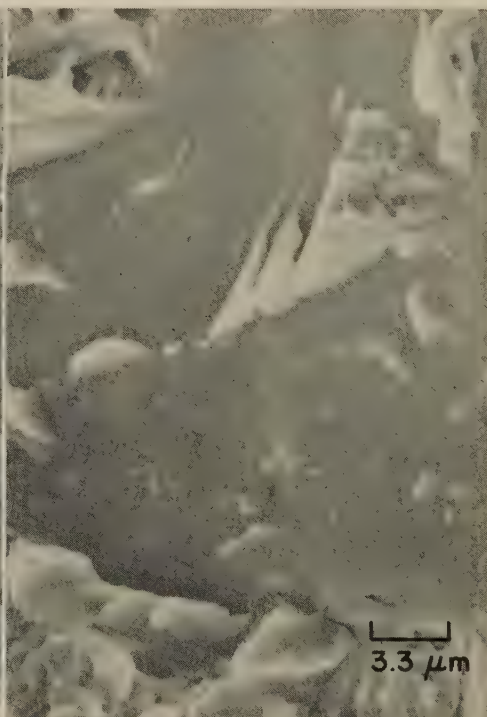
SEM fractograph 3000×
3855 Higher-magnification view of the area in the rectangle in fractograph 3854 (at left). A tonguelike formation is visible (at left center) on the flat surface of a grain. Tempering has produced embrittling networks of carbide particles.

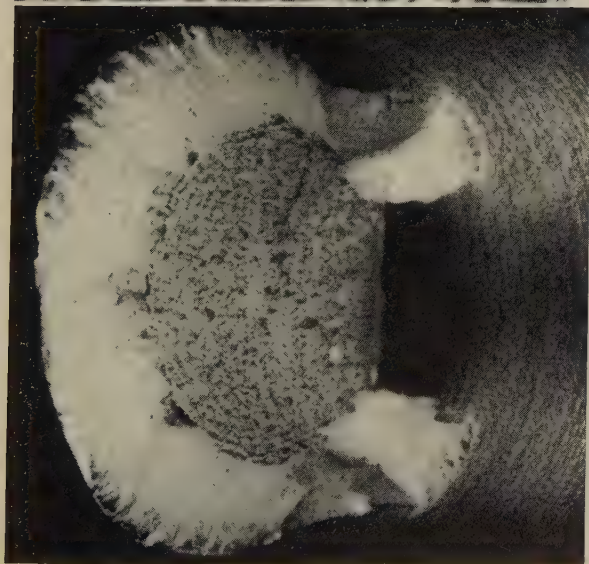
Light fractograph
3856 A classic example of cup-and-cone tension-overload fracture, in an unnotched specimen of 13-8 PH stainless steel with a tensile strength of 1634 MPa (237 ksi) and 47% reduction in area. There are circumferential secondary cracks at the base of the shear lip. See also 3857 (right).

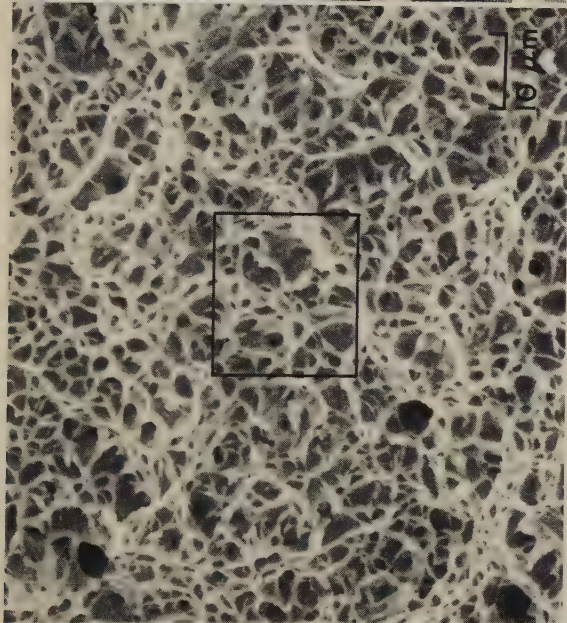
SEM fractograph
3857 SEM view of an area in the flat, central region of the fracture surface in 3856 (left), showing the equiaxed dimples of rather uniform size that are expected in this type of fracture. The scattered ridges produce the fibrous appearance seen at low magnification (3856). See fractograph 3858, a higher-magnification view of the area outlined by the rectangle.

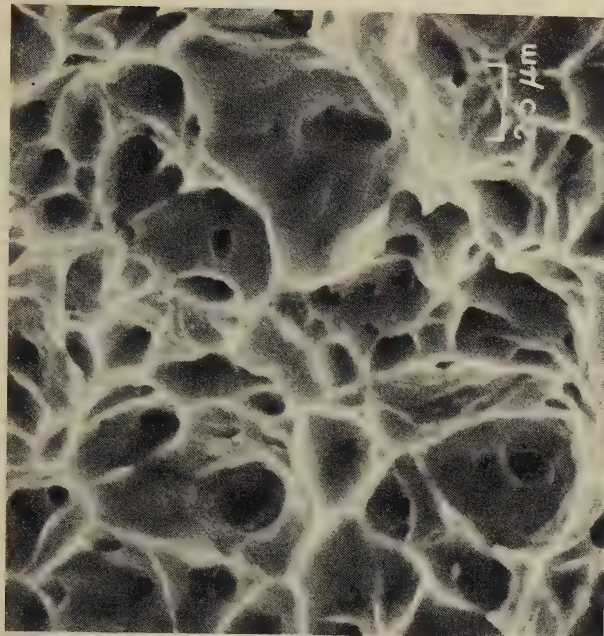
SEM fractograph
3858 Higher-magnification view of the area in the rectangle in fractograph 3857 (left), showing small dimples within dimples of moderate size, as well as very tiny voids in the membranes separating the dimples of moderate size. Note that there are almost no inclusions.

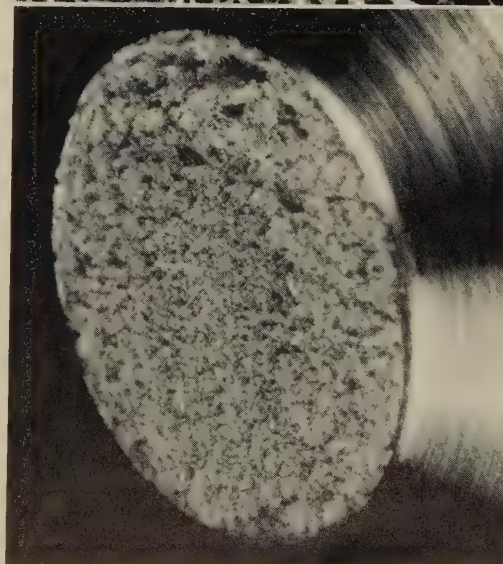
Light fractograph
3859 A typical tension-overload fracture in a notched specimen of 13-8 PH stainless steel with the same properties as those of the specimen in 3856. The fracture surface appears uniformly fibrous, with a hint of a shear lip. See also fractograph 3860 (at right).

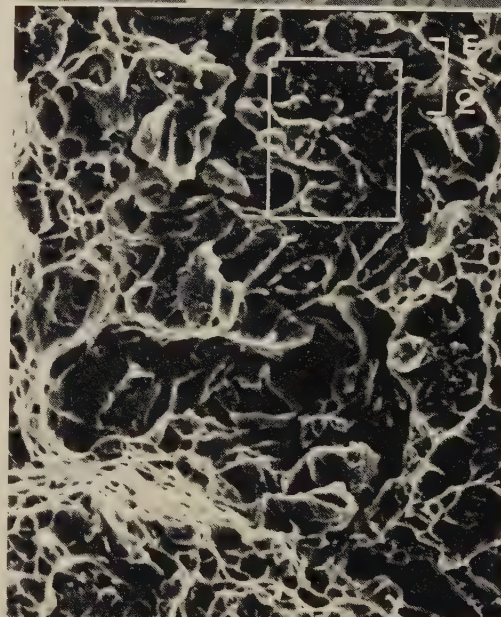
SEM fractograph
3860 SEM view of an area of the fracture surface in 3859, showing dimpled rupture in some regions (at left, for example) and, elsewhere, facets that suggest local quasicleavage without evidence of any conventional river patterns. See fractograph 3861 (at right), a higher-magnification view of the area in the rectangle.

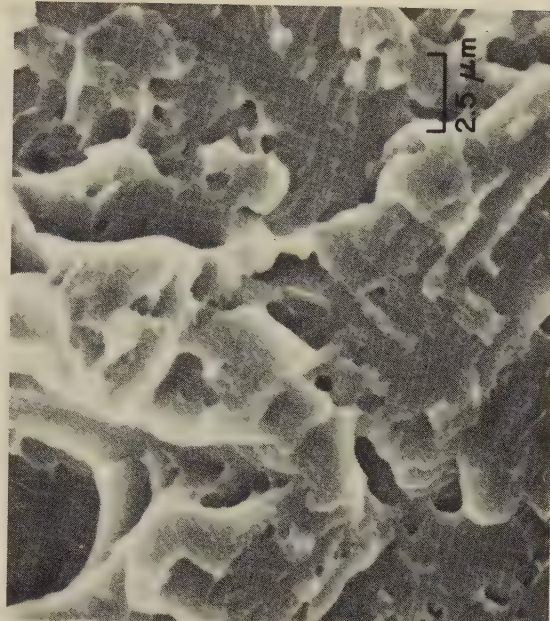
SEM fractograph
3861 Higher-magnification view of the area in the rectangle in 3860 (left). This SEM view shows that in the fine-scale structure there do appear to be some delicate cleavage steps, particularly at right.

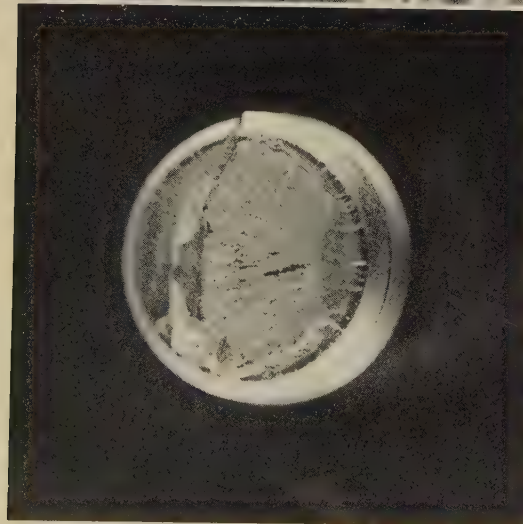
Light fractograph
3862 Low-cycle fatigue fracture in threaded specimen of 13-8 PH stainless steel (tensile strength, 1634 MPa or 237 ksi; 47% reduction in area) tested in tension-tension ($R = 0.1$) with maximum loading at 60% of tensile strength. Fracture, at 16,000 cycles, began at lower edge of crescent-shaped area at bottom.

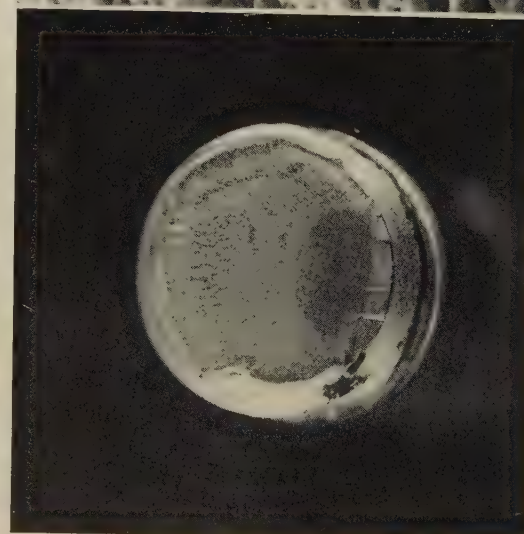
Light fractograph
3865 High-cycle fatigue fracture in threaded specimen of 13-8 PH stainless steel (same properties as for specimen in 3862) tested in tension-tension ($R = 0.1$) with maximum loading at 30% of tensile strength. Fracture occurred at 959,000 cycles. Note the crescent-shaped crack nucleus. See also 3866 and 3867.

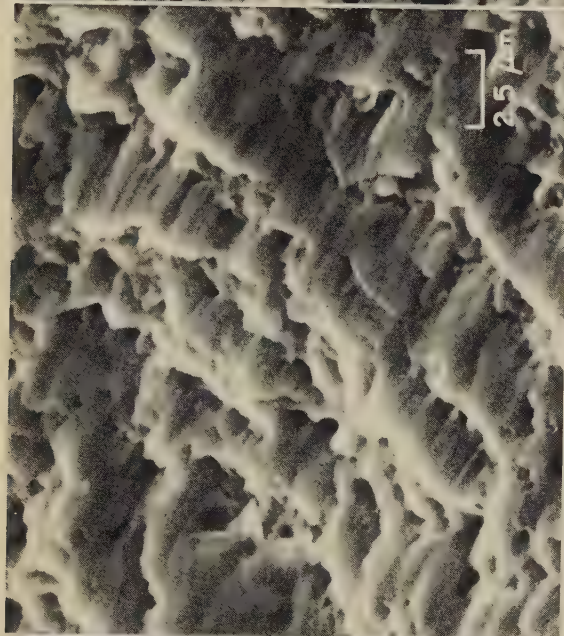
SEM fractograph
3863 SEM view of the fracture surface in 3862 (at left), taken at the rounded lip at the bottom edge of the crescent-shaped area. Even this close to the crack origin there are no fatigue striations. The irregular surface displays ridges formed by a shear process.

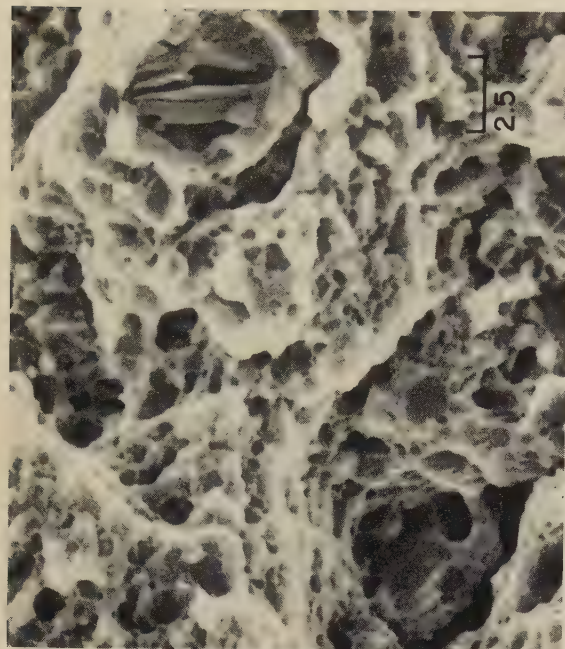
SEM fractograph
3864 Another SEM view of the fracture surface in 3862, taken in the region of final fast fracture. Fatigue fracture has given way to dimpled rupture. Two pockets, one at the left and one at the right, contain features that resemble localized quasicleavage.

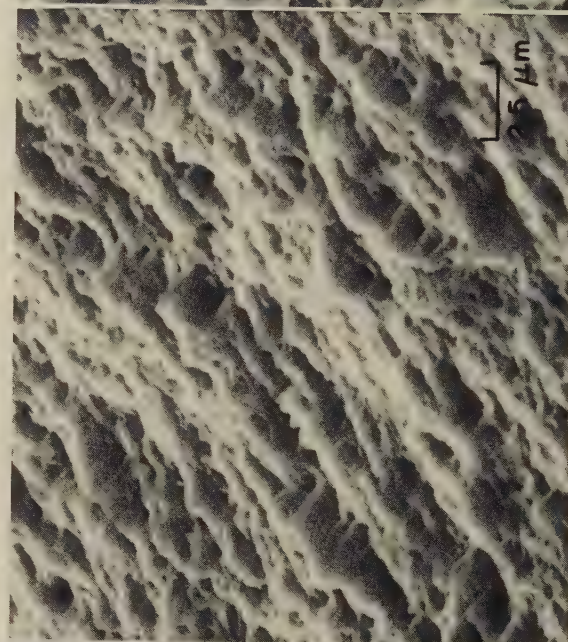
SEM fractograph
3866 SEM view of fracture in 3865 (at left), taken as close as possible to the bottom edge of the origin region. This rough surface does not contain fatigue striations, but instead suggests a shear mechanism of fracture and bears considerable resemblance to 3863.

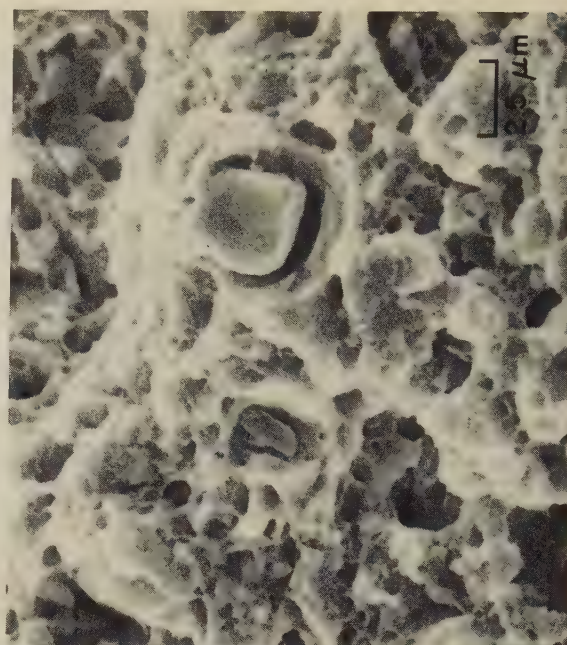
SEM fractograph
3867 View of the fracture surface in the fast-fracture region in 3865, showing basically equiaxed dimpled rupture but also containing scattered features of quasicleavage. Some regions display heavy concentrations of extremely small dimples.

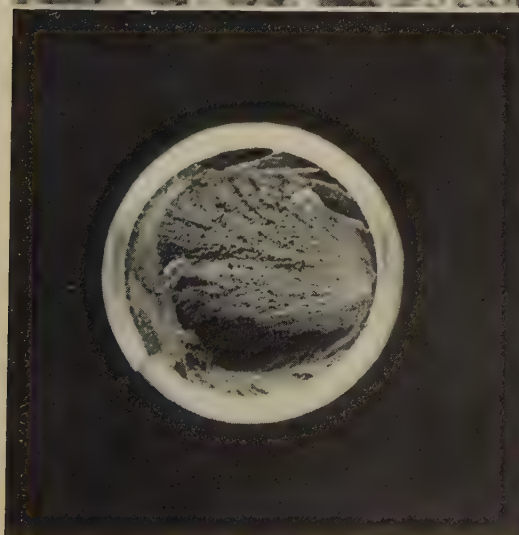
Light fractograph
3868 Surface of a fracture in a threaded specimen of 13-8 PH stainless steel (same properties as for the specimen in 3862) that was heavily charged with hydrogen by plating without subsequent baking. The specimen broke during loading. The crack origin, visible at bottom edge, grew both circumferentially and radially. See also fractograph 3869.

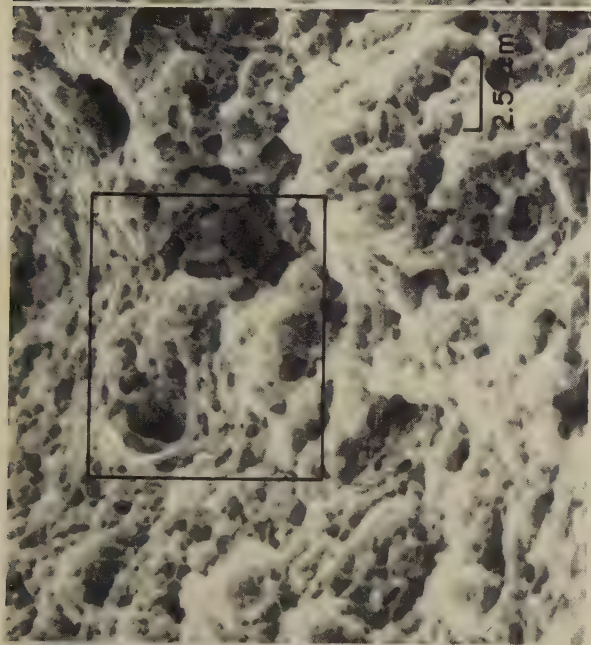
SEM fractograph
3869 SEM view of a region of the fracture surface shown in 3868 (left), revealing none of the intergranular rupture that is characteristic of hydrogen embrittlement but instead showing the equiaxed dimples of tension overload. See 3870 (enlarged view of outlined area).

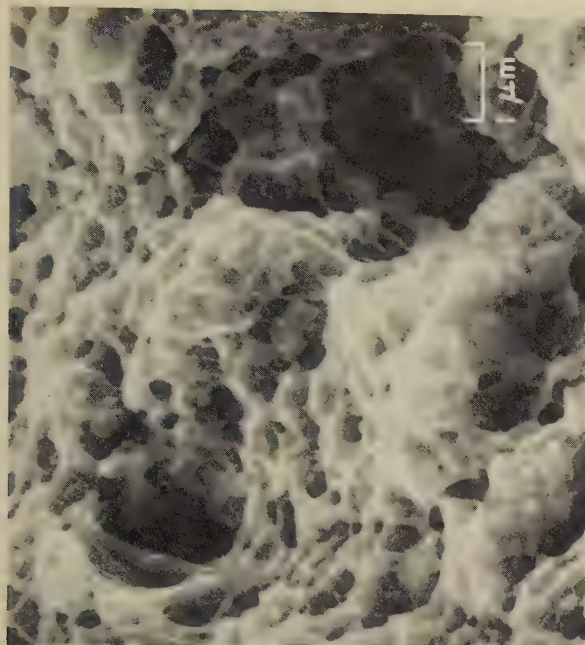
SEM fractograph
3870 Higher-magnification view of the area in the rectangle in fractograph 3869 (left), showing clearly the very dense grouping of very small dimples around larger dimples. There is no evidence here either of grain-boundary facets or of inclusions.

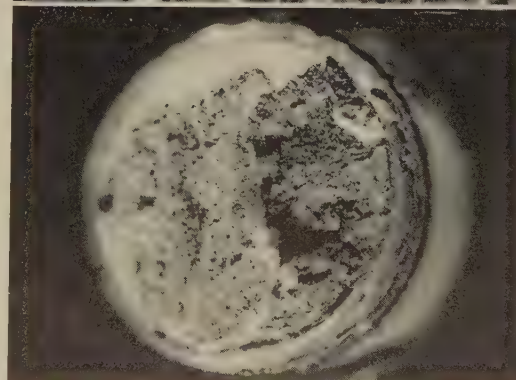
Light fractograph
3871 Stress-corrosion-cracking fracture in threaded specimen of 13-8 PH stainless steel (same properties as in 3862) loaded to 75% of tensile strength in a 3.5% NaCl solution. See 3872.

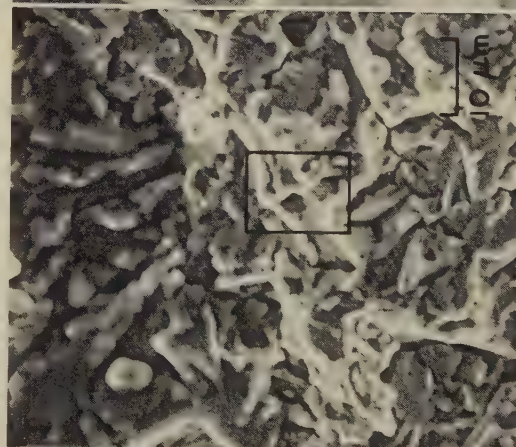
SEM fractograph
3872 SEM view of crack-origin area of fracture surface in 3871, showing corrosion products that probably are oxides. Secondary cracks may or may not extend into the metal below. See also 3873 and 3874.

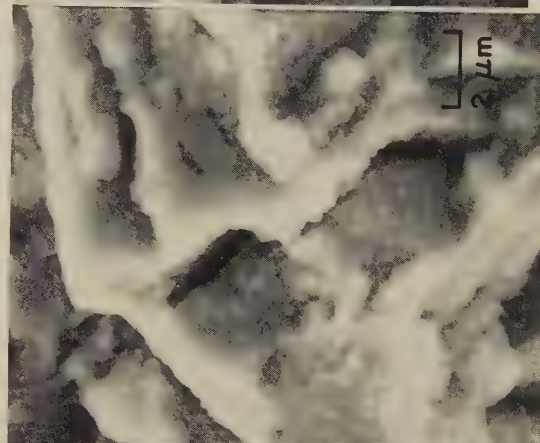
SEM fractograph
3873 Enlargement of the area in the rectangle in 3872 (left). The oxide coating appears to be quite continuous except for the scattered secondary cracks. Compare with 3874 (right).

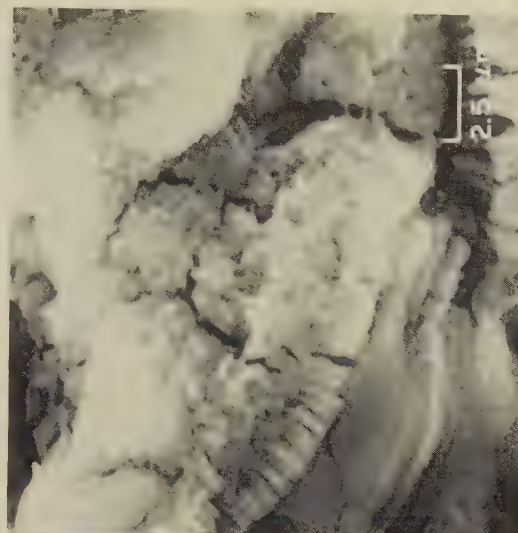
SEM fractograph
3874 Another view of the crack-origin area of the fracture surface shown in 3871, displaying a coating of a hydroxide corrosion product containing many fine secondary cracks. Compare with the area shown in fractograph 3873 (left).
